Build 19 Information

This is a presentation on the changes in build 19.

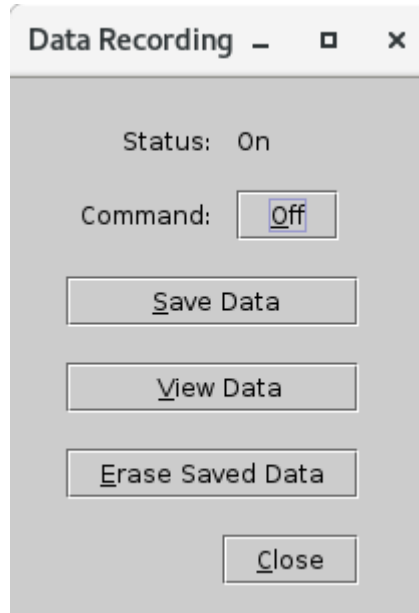
Level 1 Recording

- Recording can be stopped via the Data Recording window on the RDA HCI (see screenshot below)
You do not need to be logged in to the RDA HCI to stop recording

"Level 1 Recording should only be stopped when directed by the ROC to preserve a data case"

Note that this same window can still be used to “save” up to 4GB of data to be written to a DVD at a later time

The data “saved” are from the already saved VCP data, not new VCPs

This window only saves the data to a new location to keep them from being deleted.

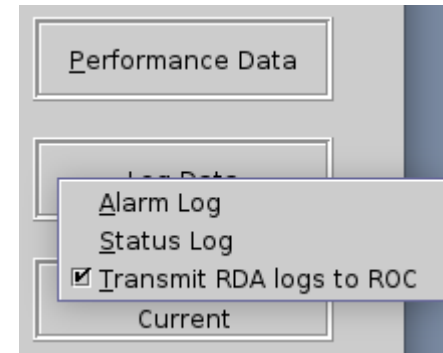
This option is on by default

It can be turned off on the RDA HCI by selecting the Log Data and unchecking the Transmit RDA logs to ROC option (see below)

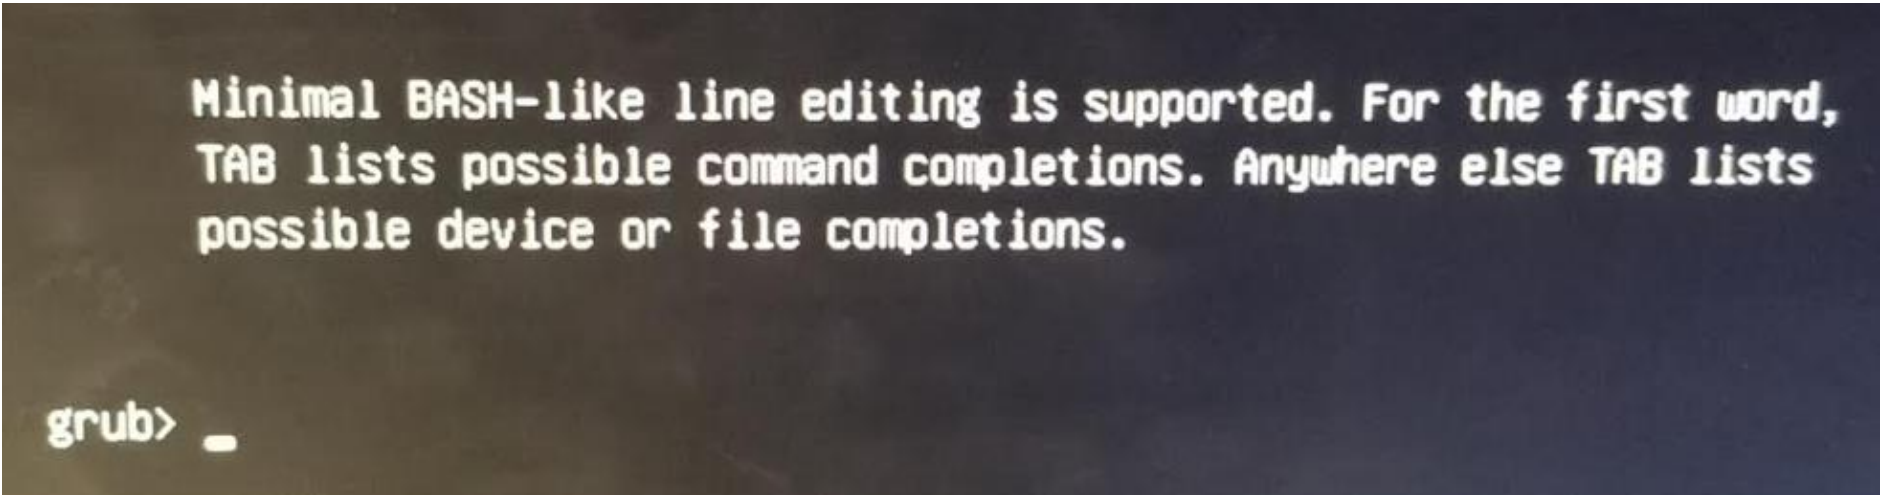
At Attachment 1, Step 12 you select a specific hard drive and press <Enter>

However, if you click OK with the mouse instead, the load will fail with the following error being displayed

A screenshot of a GRUB terminal window with a dark blue background and yellow text. The text reads: "Minimal BASH-like line editing is supported. For the first word, TAB lists possible command completions. Anywhere else TAB lists possible device or file completions." In the bottom left corner, the prompt "grub> _" is visible.
